Spurn and Kilnsea in 2013: the weather and tidal events

| Jan Crowther

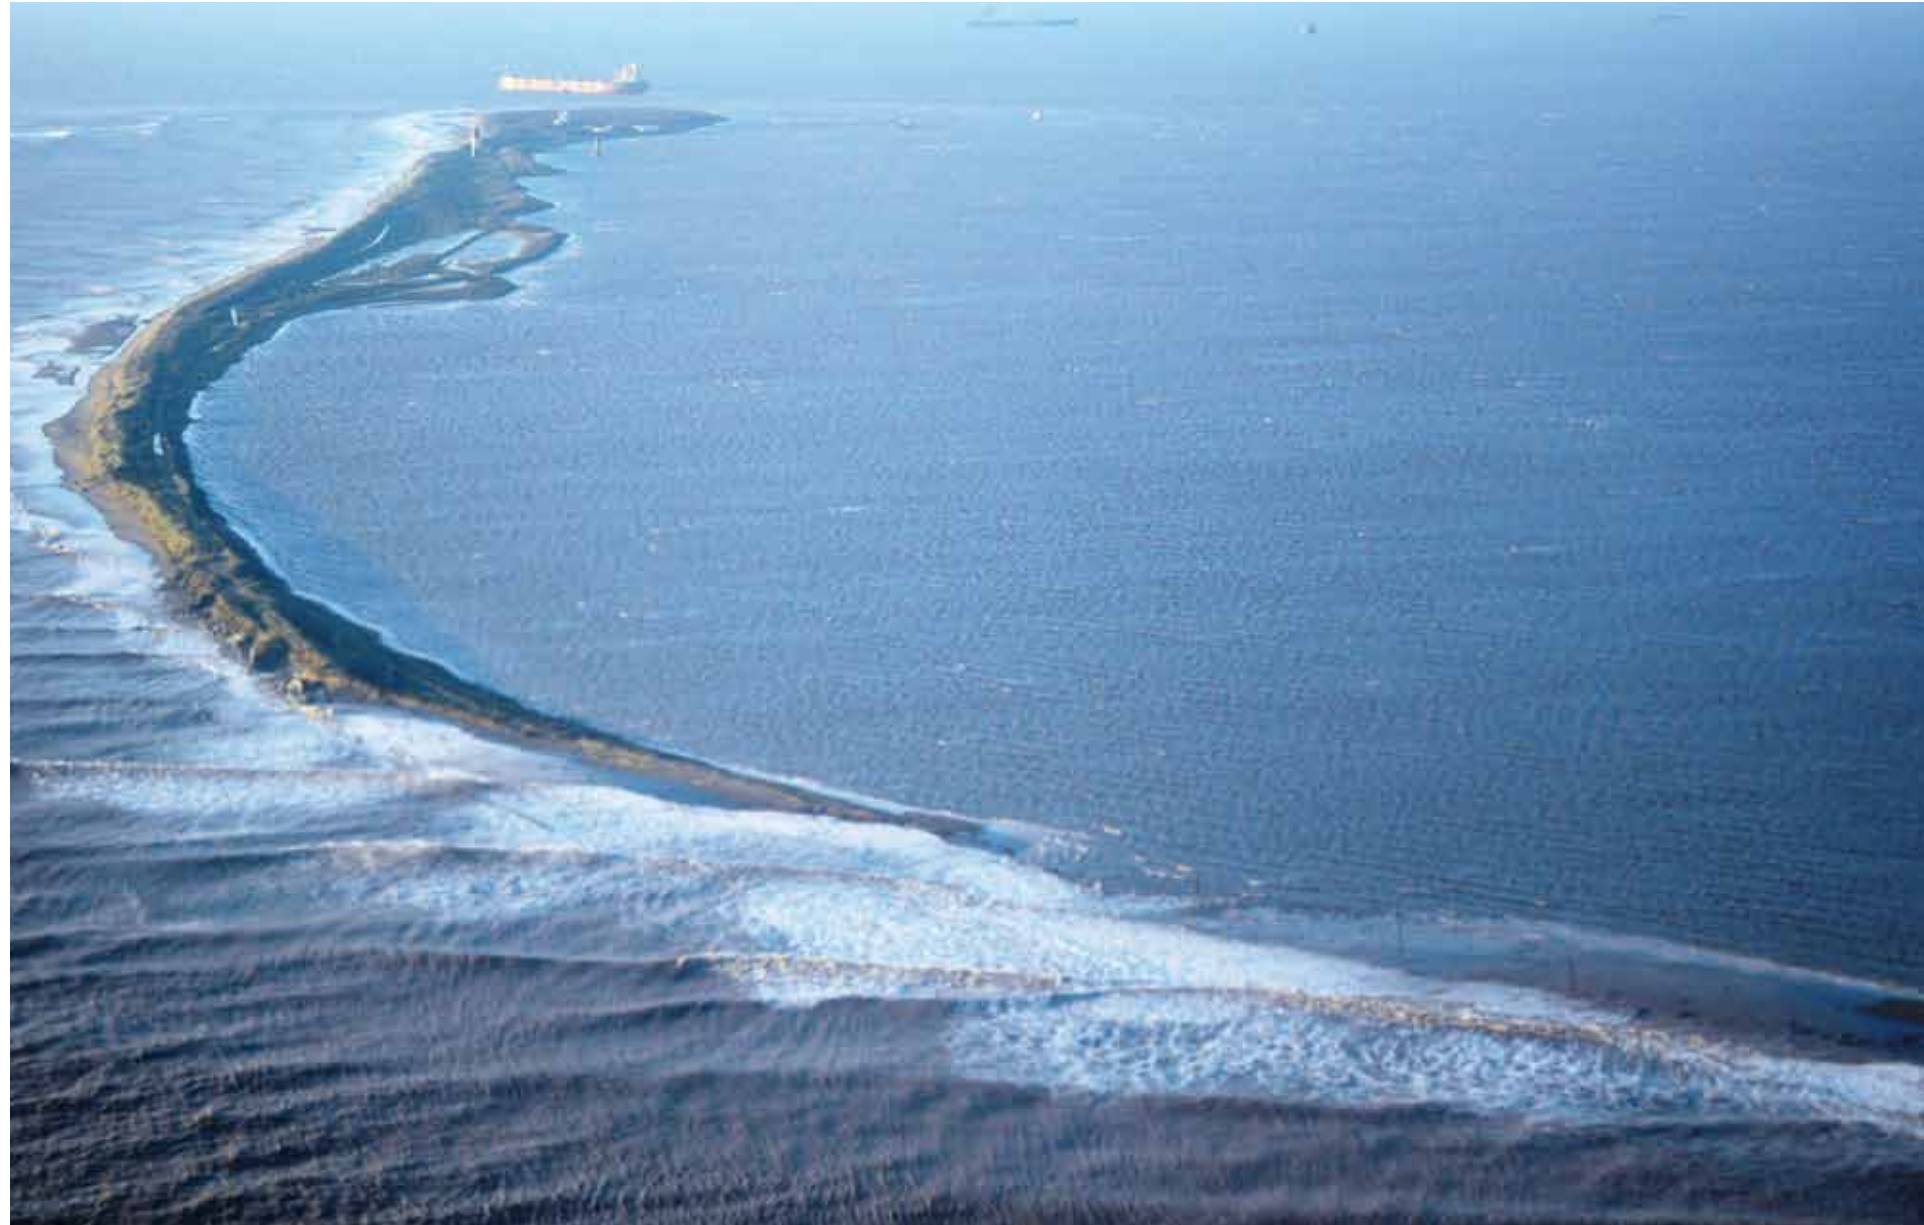
The storm surge breaches the narrows on the peninsula © Environment Agency copyright 2013. All rights reserved

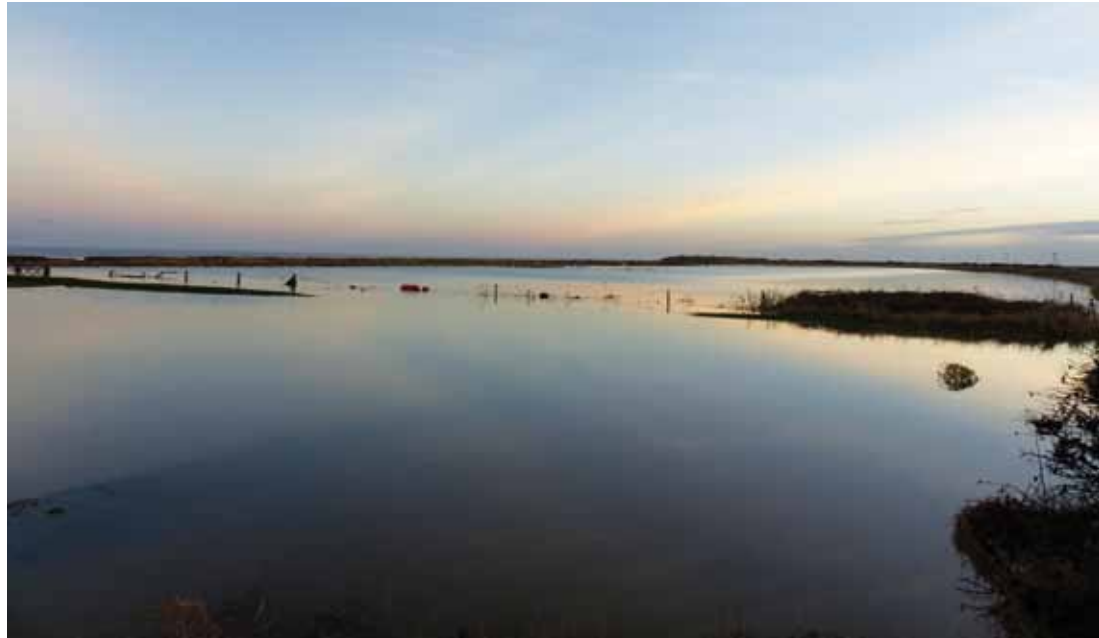
The Blue Bell car park and the borrow pit, 6.12.13 • Tim Jones

sea, was quickly over-topped. Water flooded into the new borrow pit, and onto the Blue Bell car park, making it impossible to distinguish one from another. The Blue Bell Café and Information Centre, Blue Bell Cottage, Warrenby Cottage and Fourways were all flooded. The sea threw boulders and rubble onto Clubley's Field, though fortunately only a few metres of the field were affected and the sea-watching hide was not damaged. However the corner of Clubley's Field, just south of the hide, where it had always been possible to step down onto the compound was washed away, and the sea ran into the compound and covered it with sand. The Heligoland trap was now uncomfortably close to the beach. From Spurn gate southwards the waters covered the road and the little sheep field. The YWT Information Centre and Barry's old bungalow were flooded. The Ringing Lab, where fortunately all important paper work had been removed to a higher level, was over a foot deep in water.

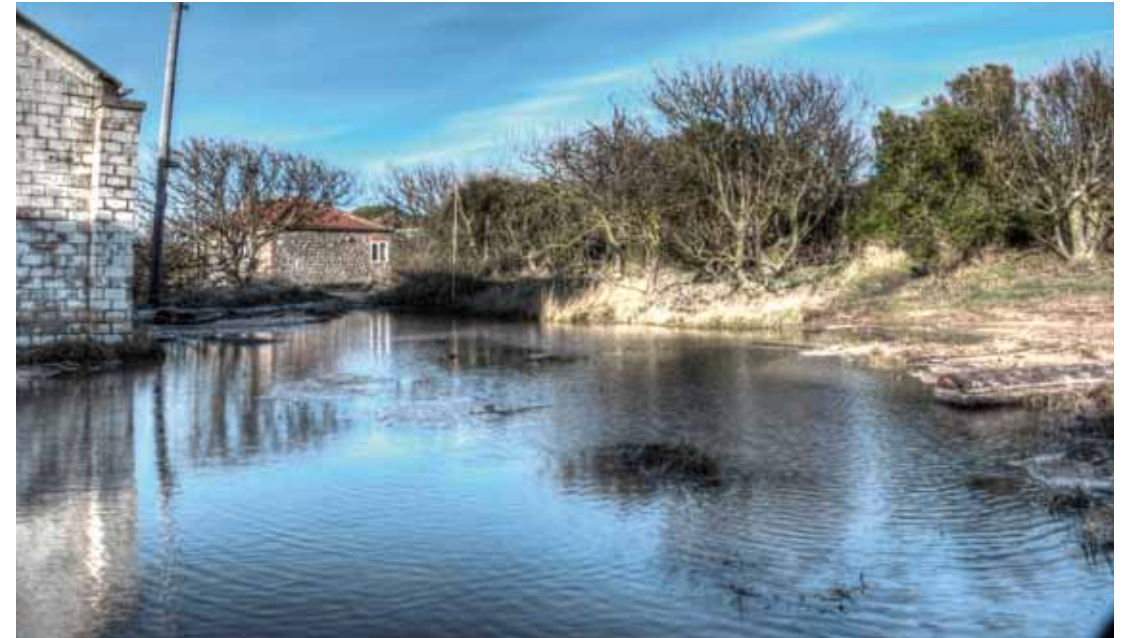
Looking towards Warren Cottage, 6.12.13 • Garry Taylor

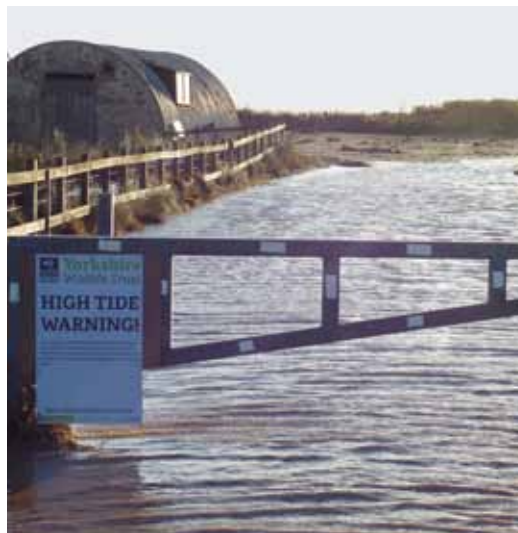
The morning after the surge, the Warren, 6.12.13 • Tim Jones

The damage at the northern end of the peninsula was quite amazing, and has changed both the landscape and access by road to the Point. The damage happened when night had fallen, but daylight revealed a scene of devastation. The tarmac road, which goes from the Warren area over an old gun emplacement and along the Humber side down to post 19 remained intact, though at its southern end it was covered with sand. From there, as far as post 31 the peninsula was unrecognisable. A large area, where the road had been,

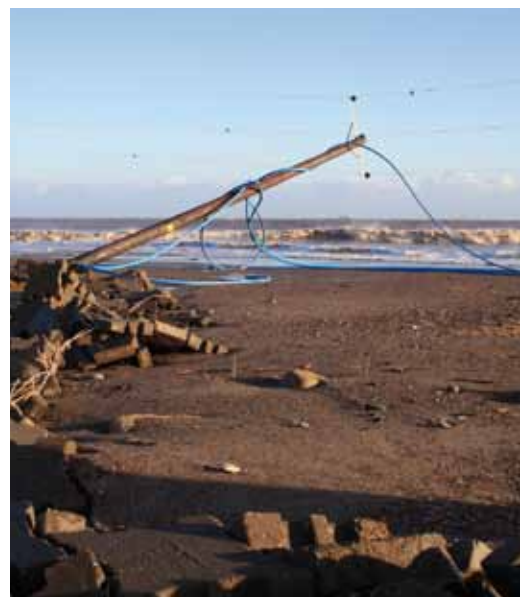
Electricity pole, water pipe and sections of the road, 6.12.13 • Dave Steenvorden

was rendered a virtually featureless beach. The sand dunes had entirely disappeared. Several electricity poles had been knocked over, so that again there was no power going down to the Point. Moreover the water pipes were exposed and damaged, which meant that the people on the Point had lost mains water too. Dave Steenvoorden, Coxswain/Station Manager of the Humber Lifeboat, was one of the first on the scene and his photographs show the blue water pipes intertwined around the electrical wires and electricity poles, with fragments of the Armorflex road scattered all around. It was (and is) very difficult to orientate oneself, as the points of reference, like the electricity poles, the road, and the wooden posts which edged the Armorflex road along the Humber foreshore were all either gone or covered with sand. The narrow dunes on the seaward side had been washed away. The length of road which has been lost is estimated to be about a third of a mile or 500 metres. From the 5th of December the sea and the river have been meeting at most high tides. This means that the situation in this area changes from day to day.

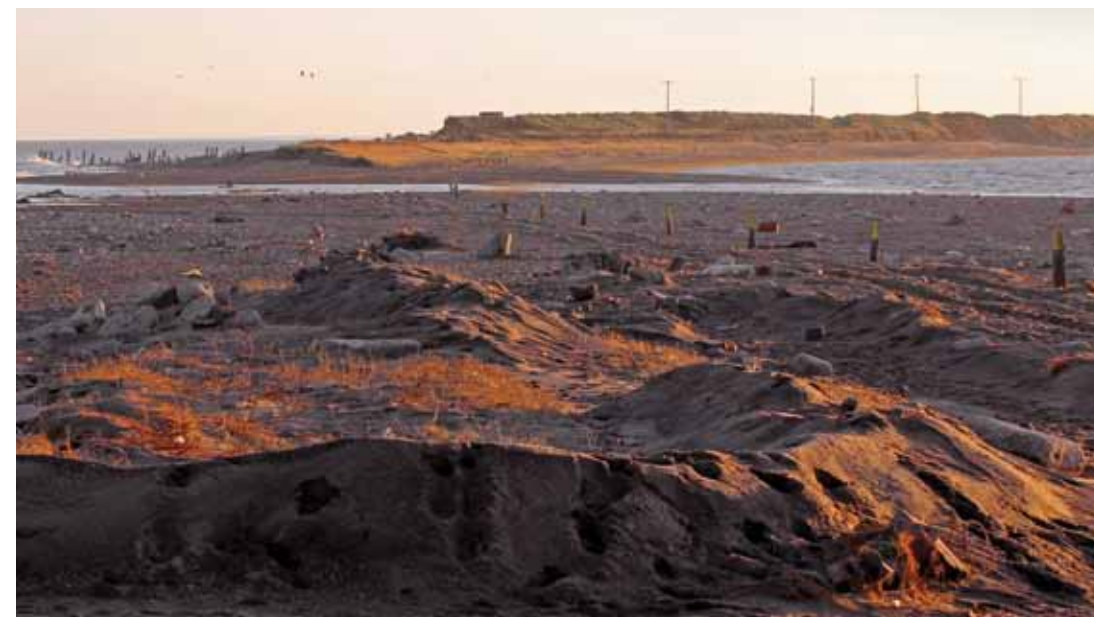
Looking south towards the Narrows, 29.12.13 • Rod Barrett
